Geotechnical Report

Reconnaissance Geotechnical Report Mat-Su Rail Corridor Mat-Su Valley, Alaska

JUNE 2003

Project Number: 32-1-01506

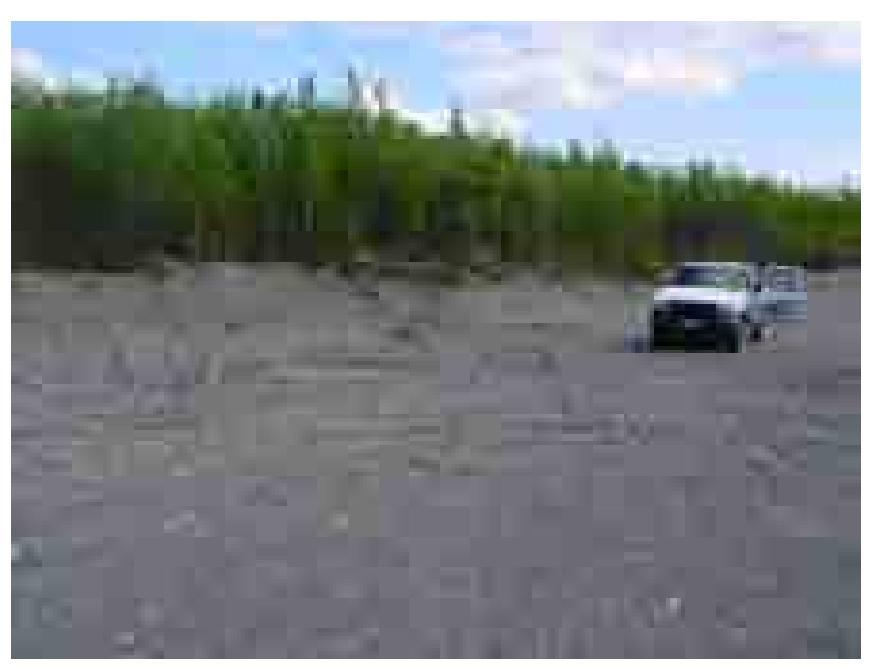
Photo 1: Station East 1, small borrow pit located at the east end of Reddane Road. Contains relatively clean sands and gravels.

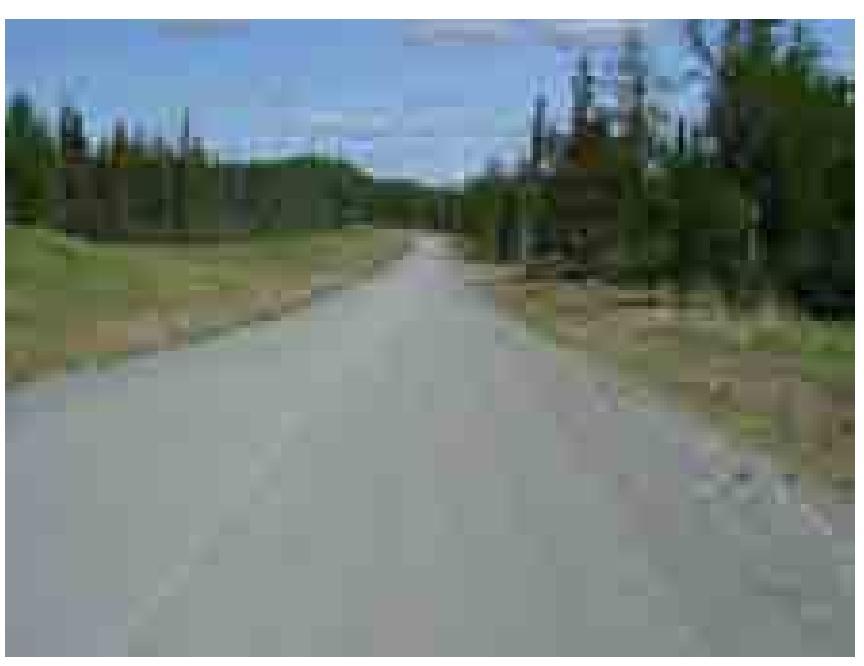
Photo 3: Station East 3, Undulating terrain north of Port MacKenzie looking north.

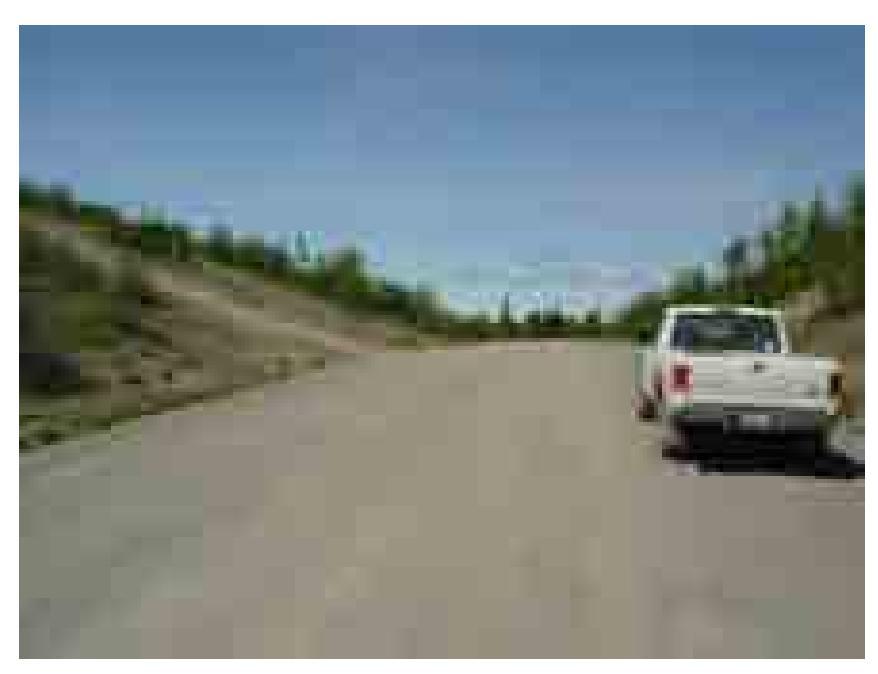
Photo 4: Station East 4, large through cut on West Point MacKenzie Road. Exposed are relatively clean sands and gravels.

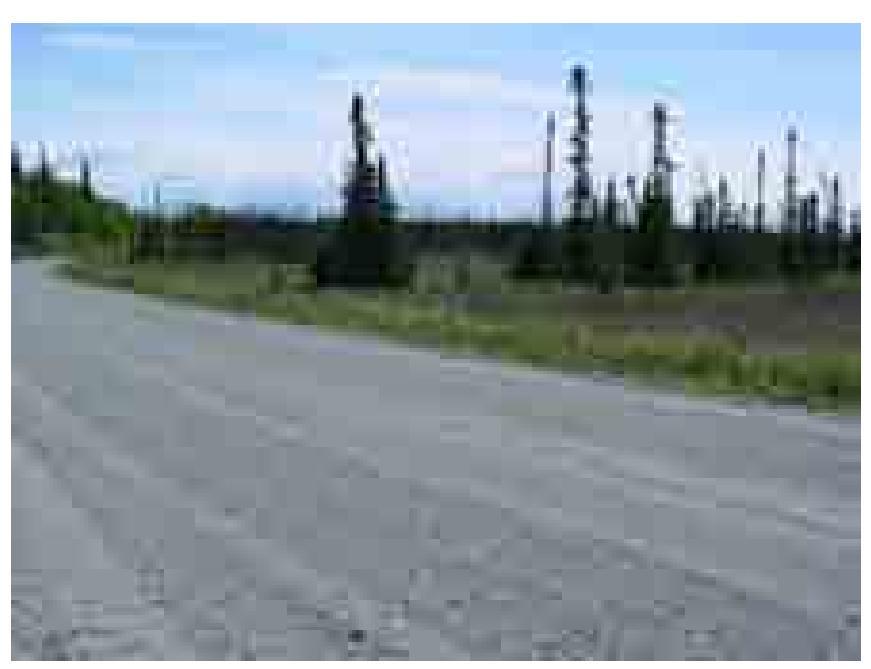
Photo 5: Station East 5, boggy area along Point MacKenzie Road. Looking southease, road grade approximately 4 feet above marsh elevation.

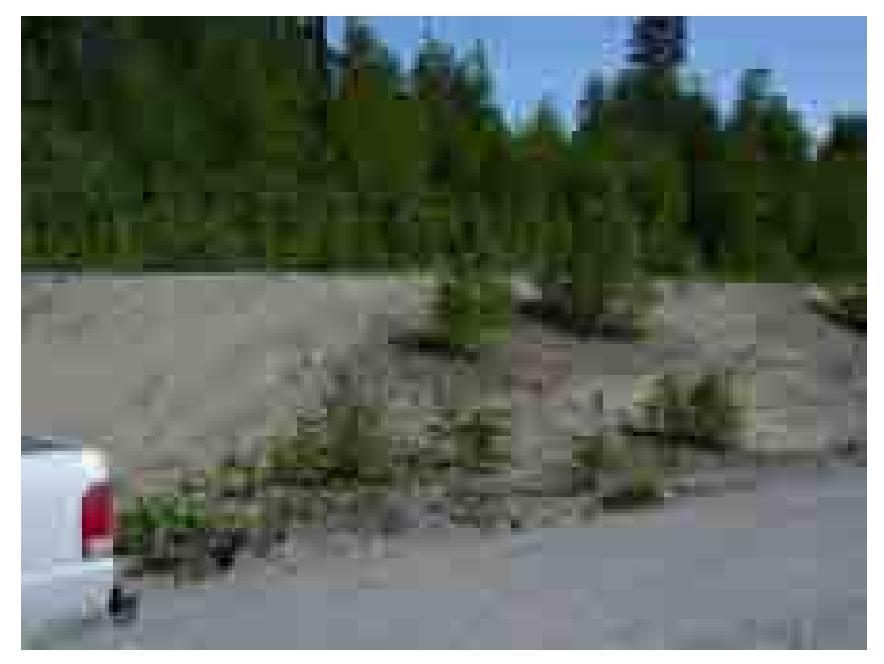
Photo 6: Station East 6, small cut on West Point MacKenzie Road looking northeast. Typically dense birch and spruce vegetation shown in background.

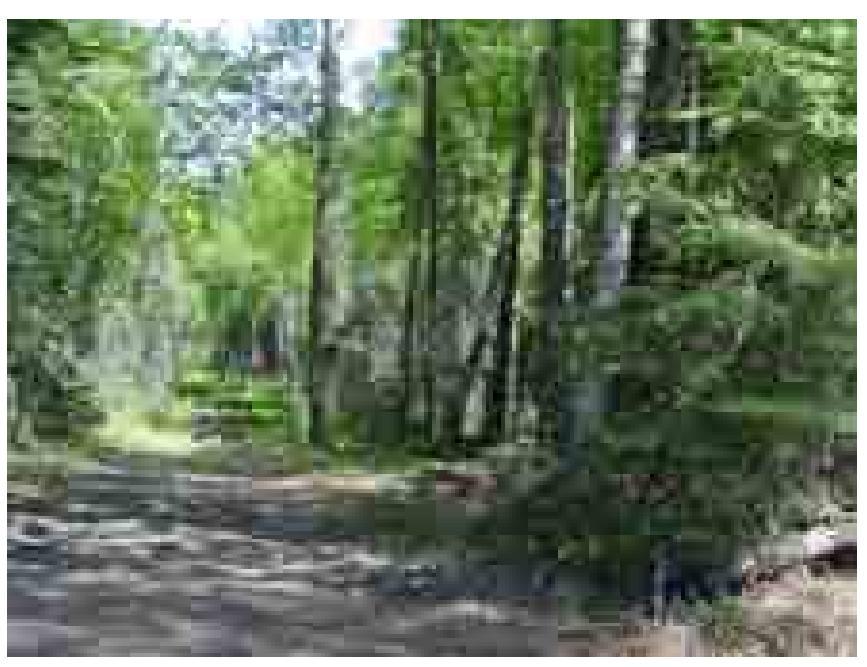
Photo 7: Station East 7, one of the many 4x4 trails found in the area penetrating into the dense birch and spruce tree stands in gently undulating terrain.

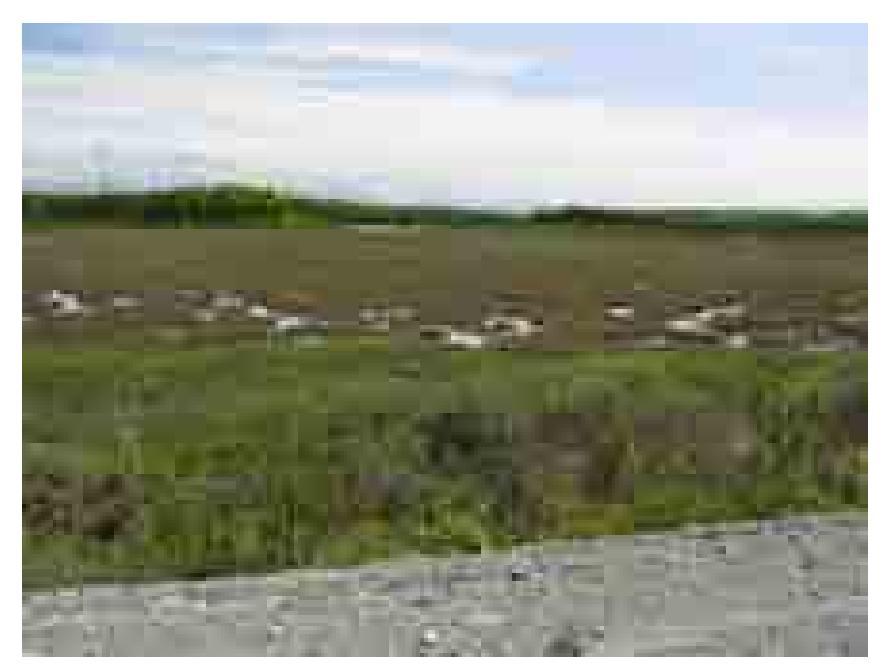
Photo 8: Station East 8, looking west from Point MacKenzie Road over a large marshy area. The marsh is present on the east side of the road to approximately the same extent.

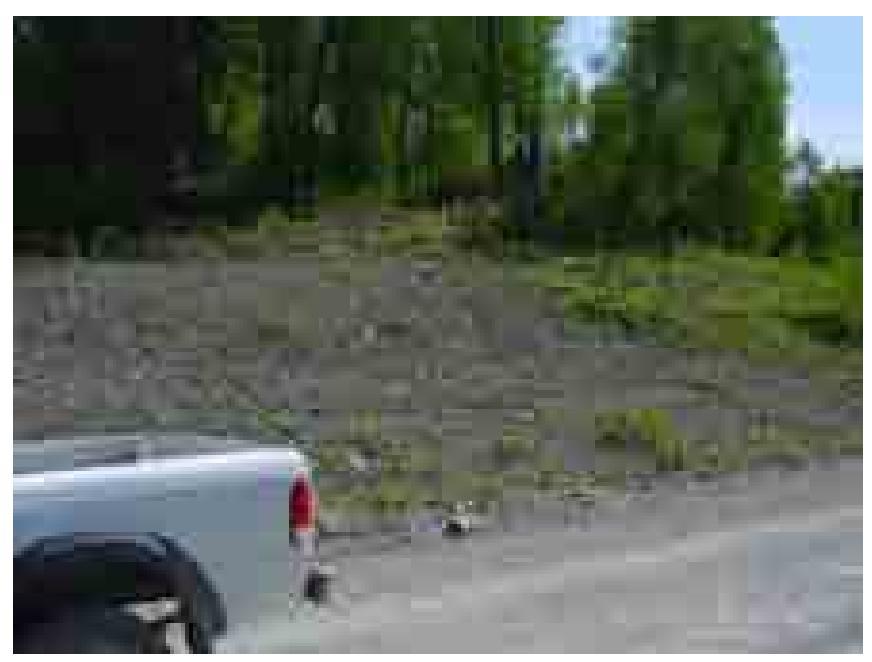
Photo 9: Station East 9, small road cut on Point MacKenzie Road exposing clean, sands and gravels.

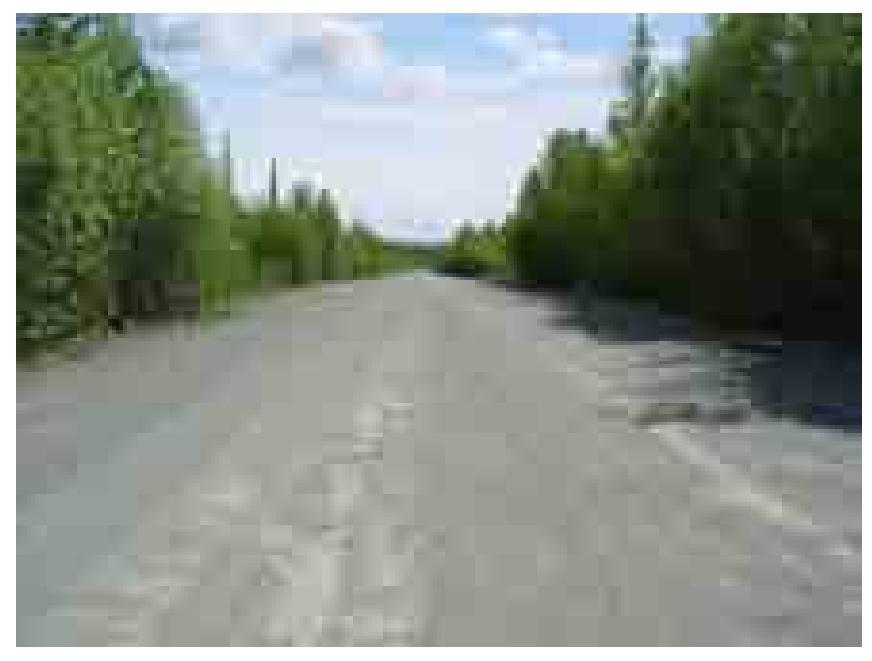
Photo 10: Station East 10, looking north on Point MacKenzie Road showing the very flat topography of this area. To the left is farming land and sloping bluff down to Goose Bay is to the right.

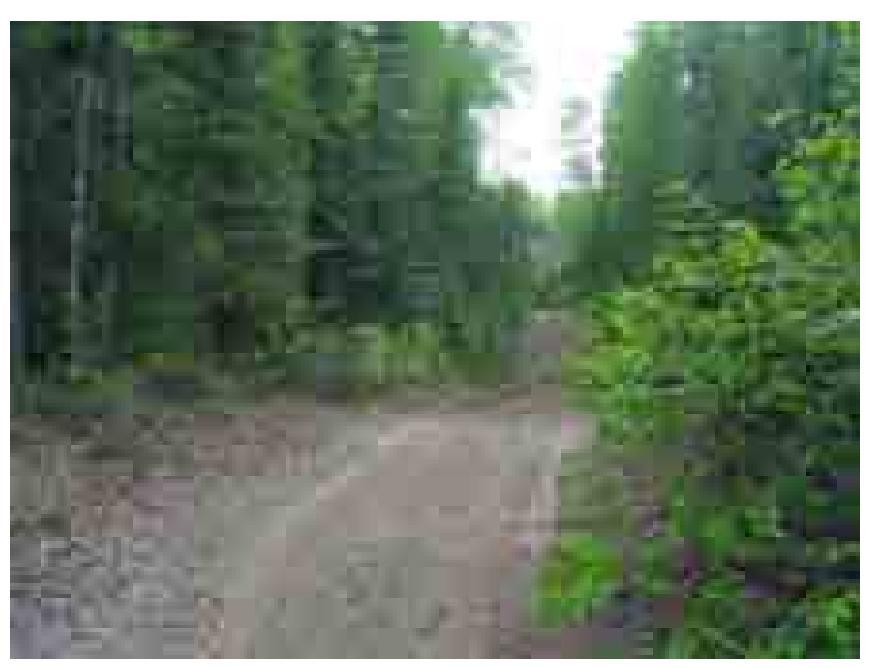
Photo 11: Station East 11, 4x4 trail north of Carpenter Road over gently undulating terrain. Shows typical dense alder, spruce, and birch trees.

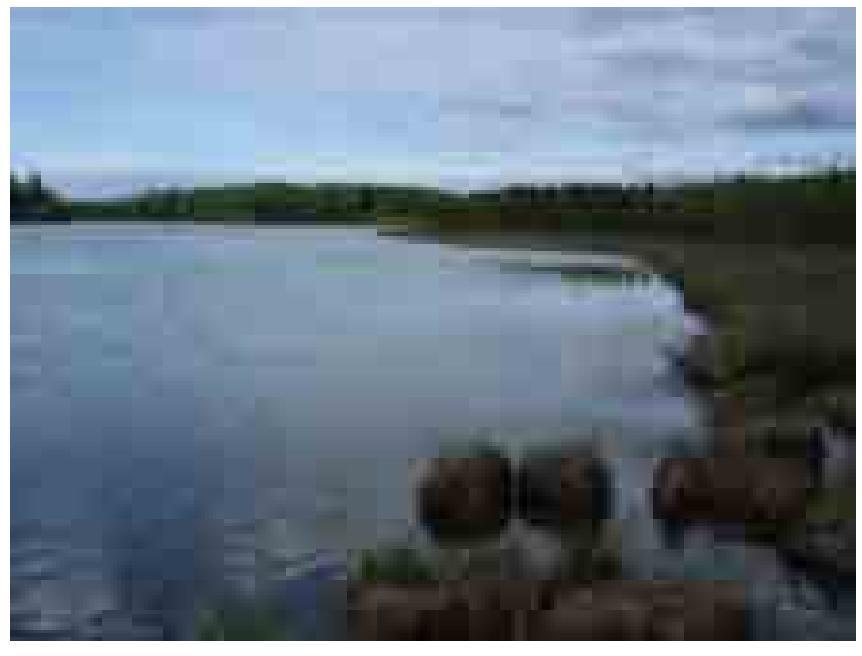
Photo 12: Station East 12, a typical marshy area that dot the terrain north of Carpenter Lake. High areas surrounding the ponds are evident by the larger trees and are likely well drained sands and gravels.

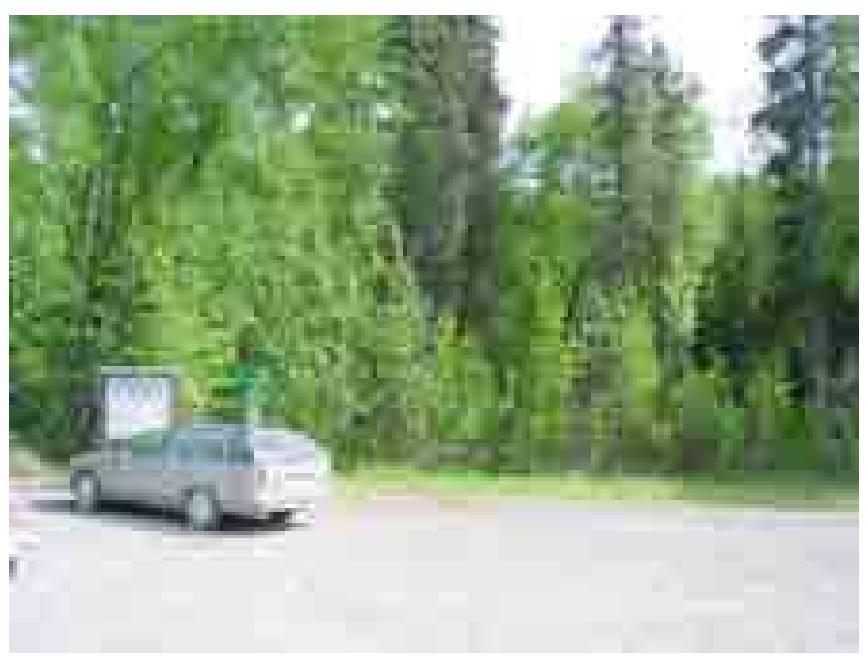
Photo 13: Station East 13, Diamond Lake parking area surrounded by typically dense alder, spruce, and birch trees.

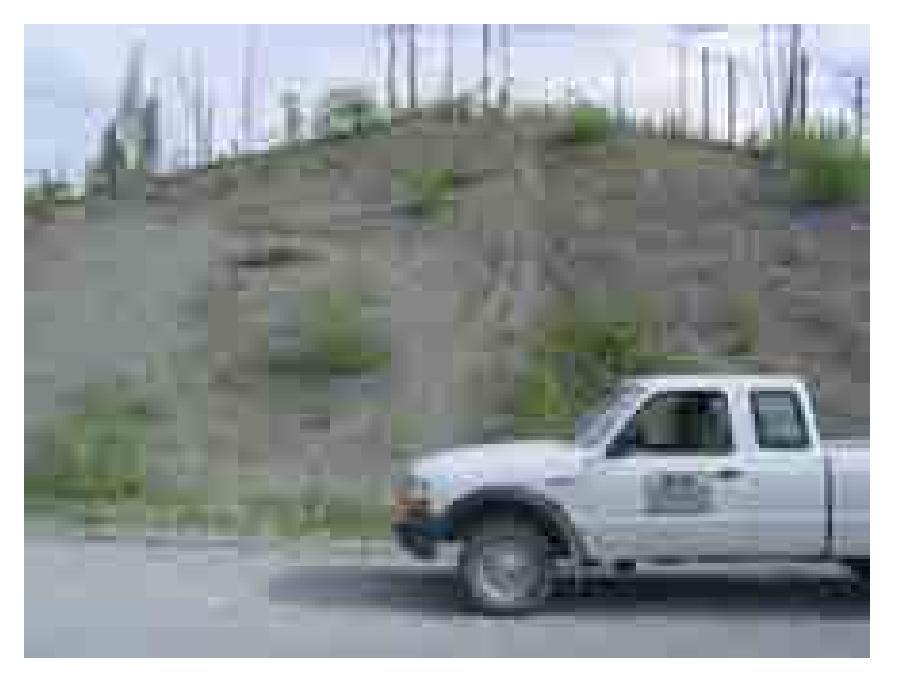
Photo 14: Station East 14, large road cut on south side of West Lakes Road north of Big Lake. Exposed soils consist of clean sands and gravels. These ridges are long narrow features separated by poorly drained marshes and Lakes.

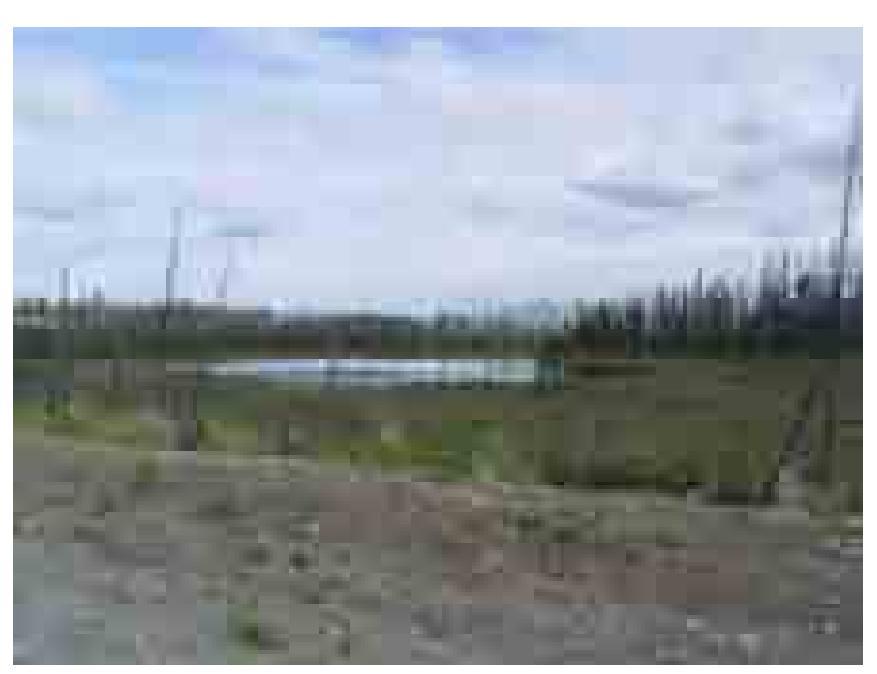
Photo 15: Station East 15, looking west over typical marsh land with a small pond north of Big Lake.

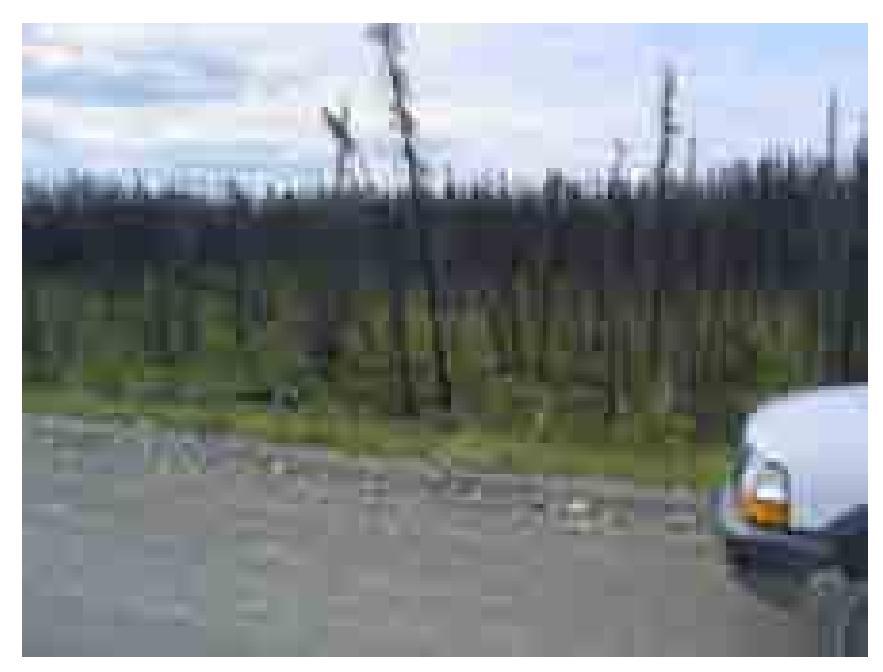
Photo 16: Station East 15, looking east over same marshy area consisting of a peat bog with sparse black spruce trees. Area was previously burned.

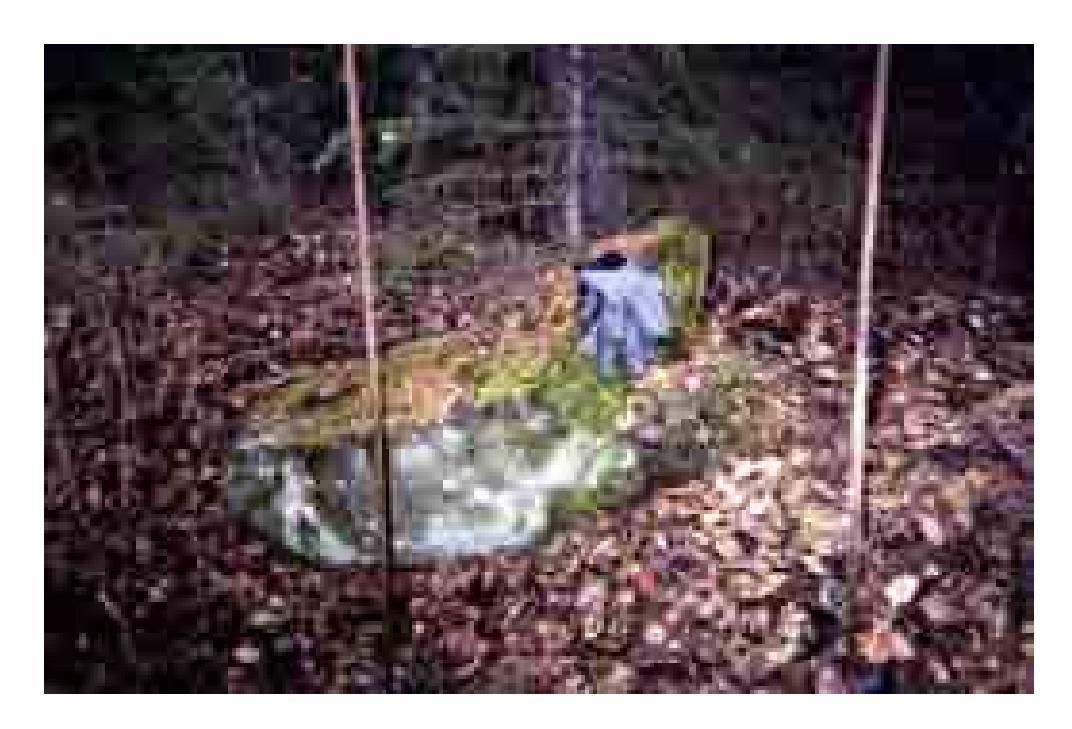
Photo 19: Station West 4, erratic encountered south of Red Shirt Lake.

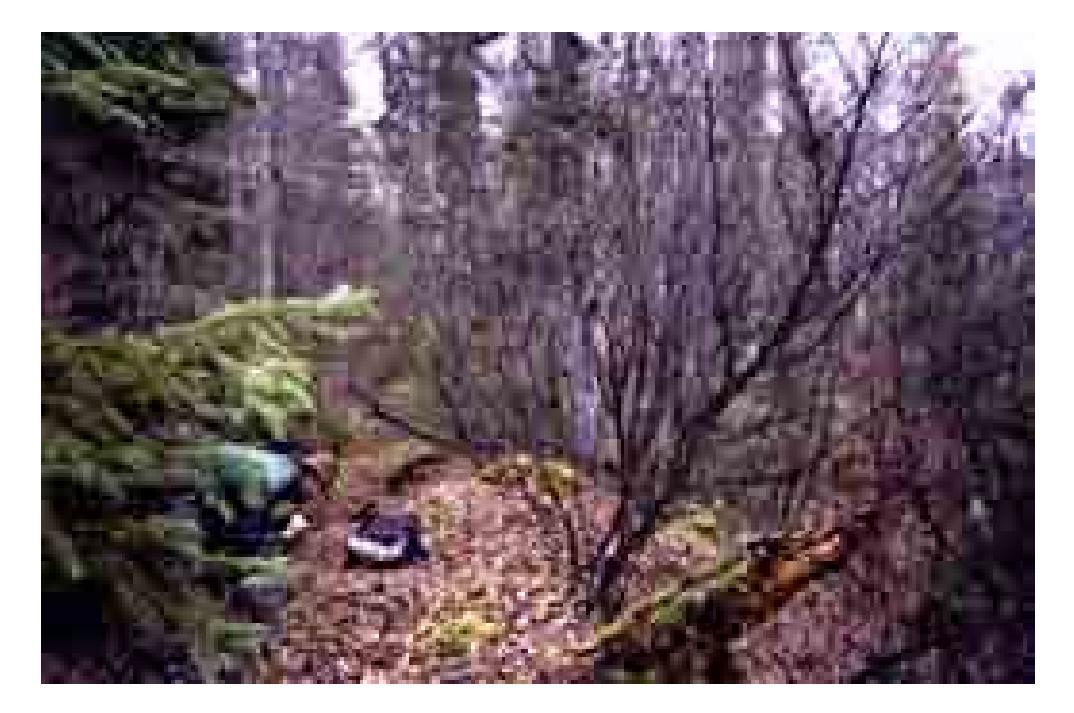
Photo 20: Station West 4, typical high spot in local hummocky terrain. High and low spots (average relief of around 30 to 50 feet) are somewhat elongated like eskers.

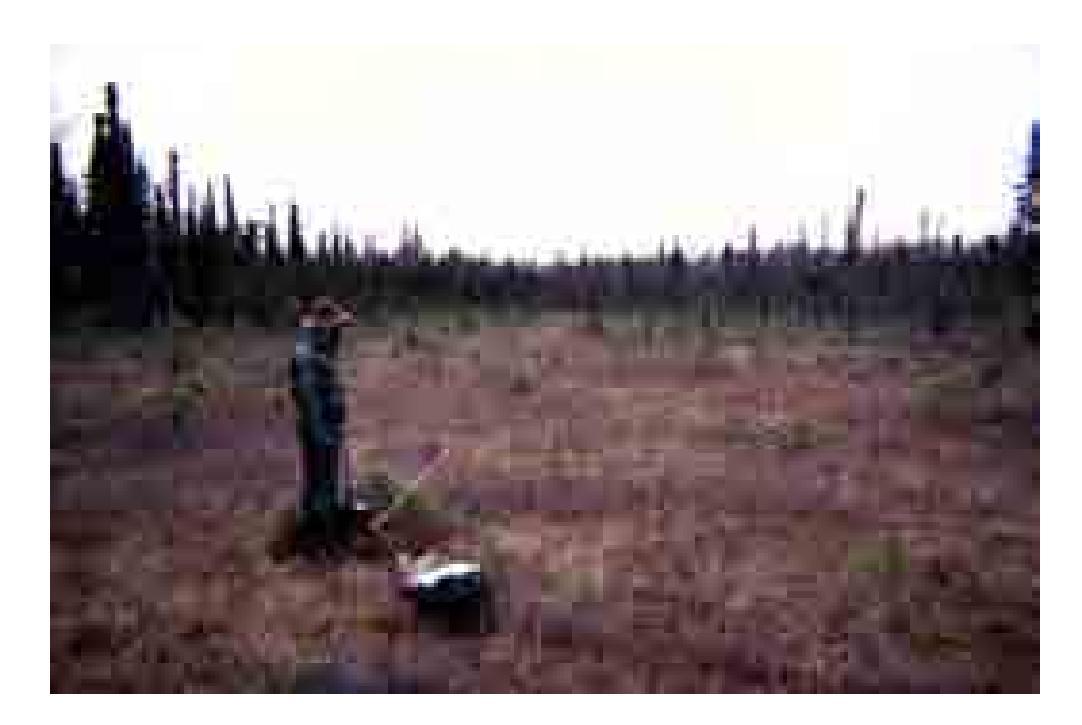
Photo 21: Station West 5, small marshy area surrounded by spruce trees. A probe penetrated 6 feet into ground and was cold and hard to retrieve, possibly frozen at depth.

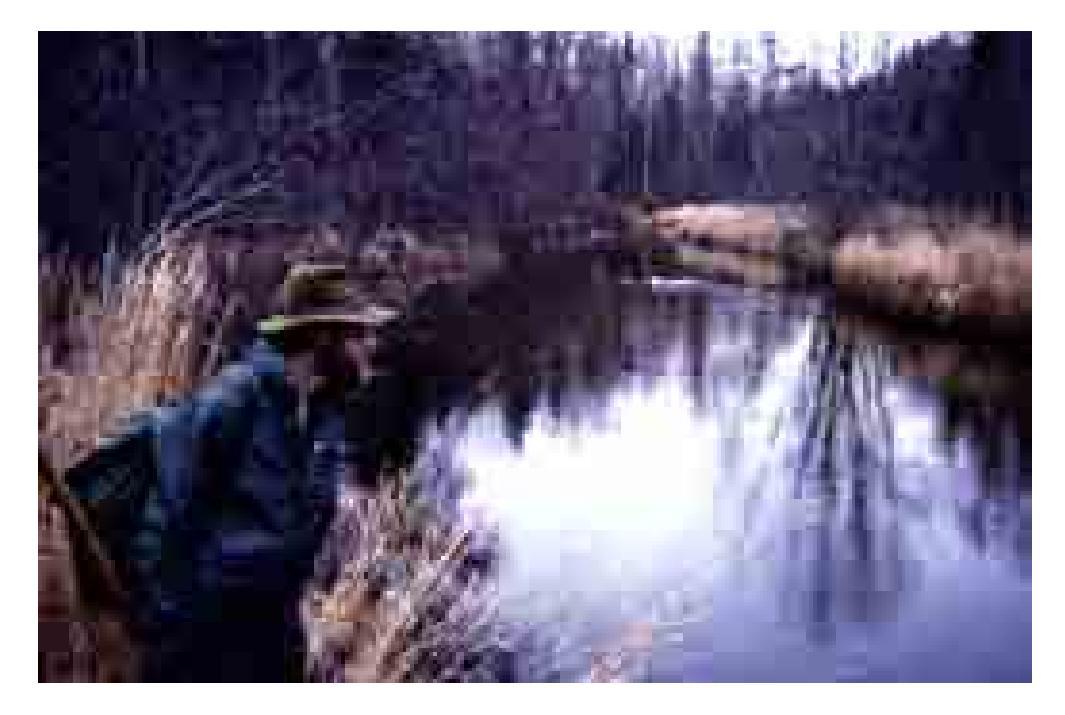
Photo 22: Station West 6, creek flowing out of Red Shirt Lake (several miles up stream). Sand and a significant amount of gravel was observed in the river bed.

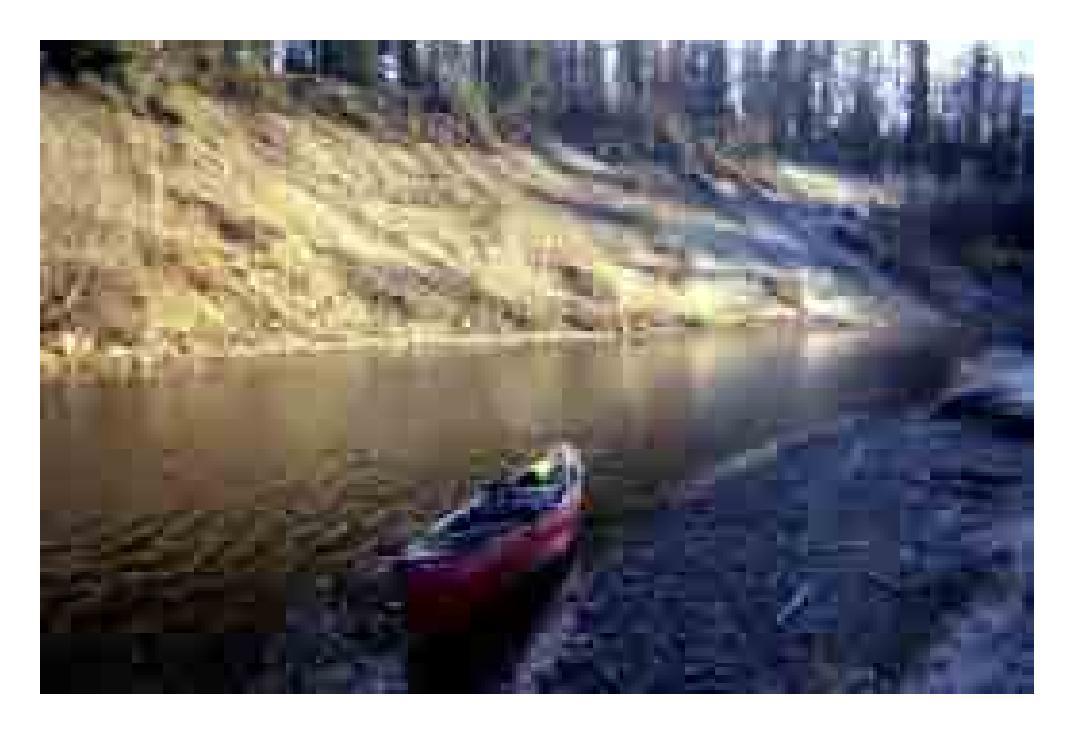
Photo 27: Station West 9, bluff on east side of Little Susitna River exposing gravelly sand soils.

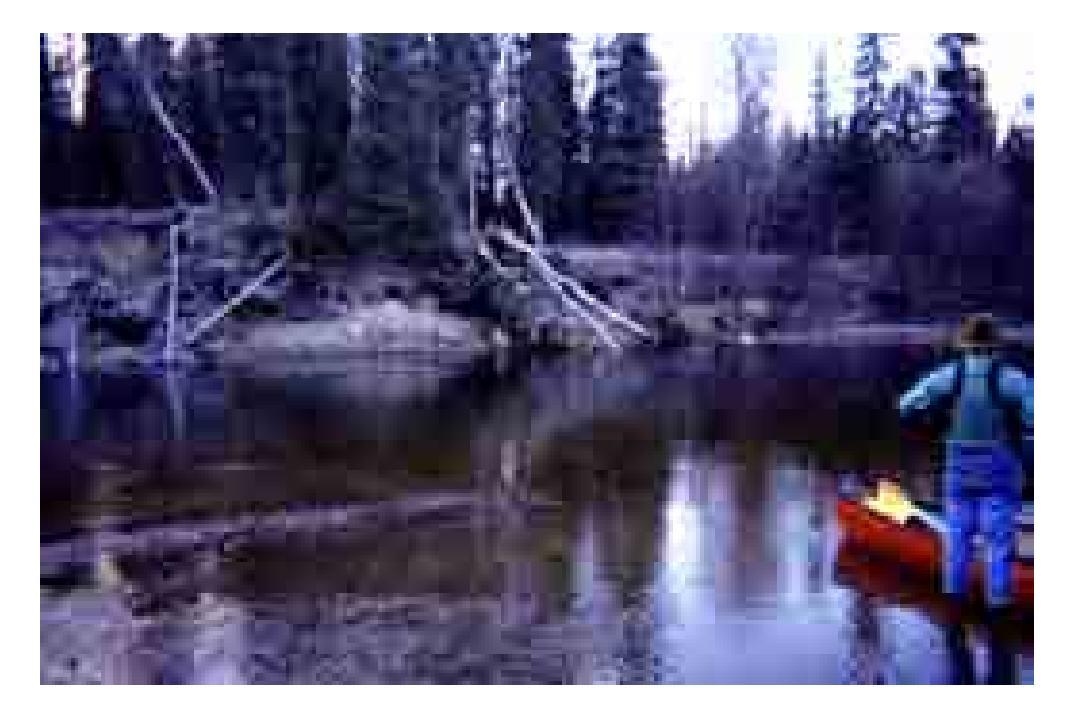
West 8	649,144 W 6,828,452 N UTM Zone 5	On western slope of large ridge. Located in a small low lying area on side of the ridge. Test pit dug revealed about 2 feet of decayed organics over hard, tan, sandy silt. The topagraphic feature is typical of low areas dotted around the ridge fromation.	Photos 25 & 26; Figure B-5
West 9	651,605 W 6,828,351 N UTM Zone 5	Approximately 75 foot high bluff on Little Susitna River exposing gravelly sand soils. Gravel is rounded. Finger shaped, small ridge lines (controlling the track of the river) appear to be smaller eskers deposited by past glaciers.	Photo 27; Figure B-6
West 10	650,885 W 6,824,813 N UTM Zone 5	Another bluff on the Little Susitna River that exposes sandy silt to silty sand soils. This bluff is only 30 feet high. The large blocks at the toe of the slope in the photographs are large chunks of frozen silt.	Photo 28; Figure B-6

Photo 28: Station West 10, bluff along west edge of Little Susitna River exposing silty sand soils. Large blocks are chunks of frozen silt.

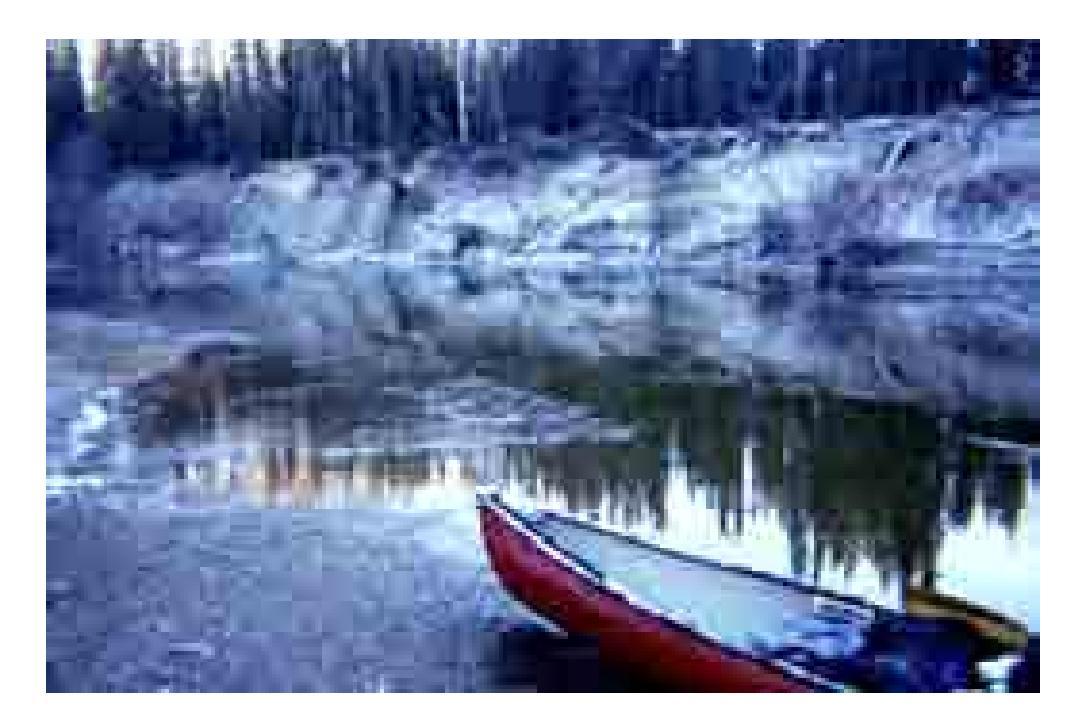
Photo 29: Station West 12, bluff on west side of Little Susitna River exposing sand and silt with isolated areas of fine gravel.

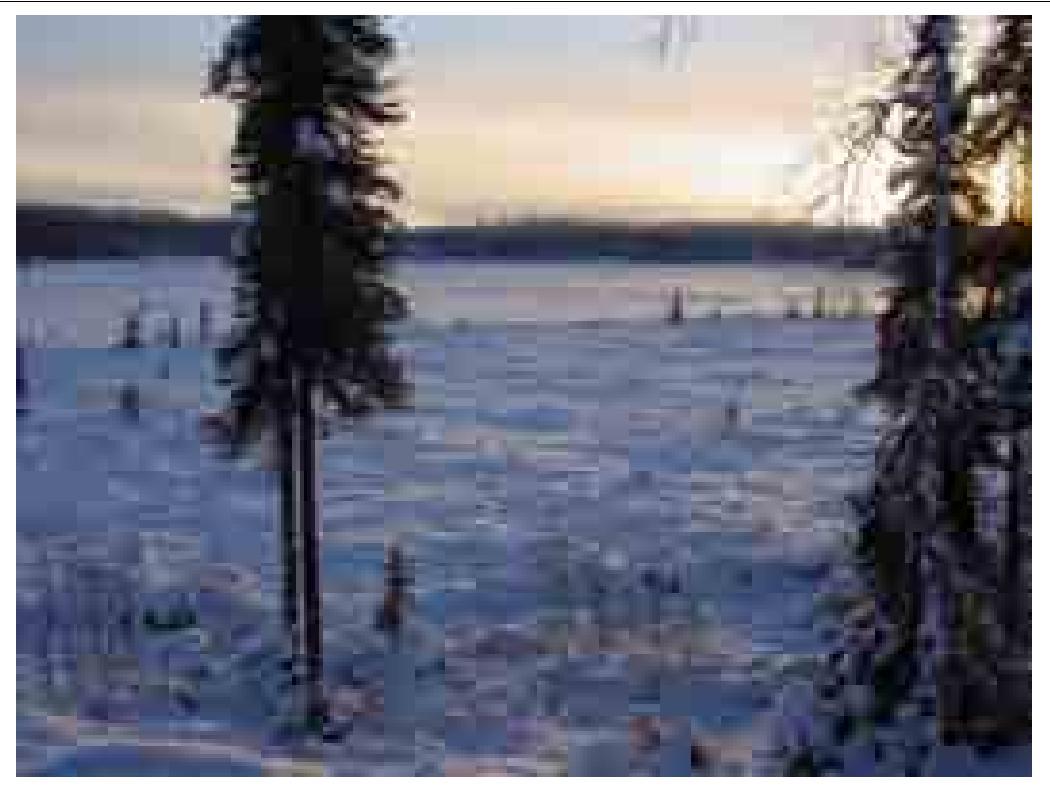
Photo 31: Station West 15, Boot Lake. Surrounded by boggy areas. Higher ground on opposite side contains larger trees and is likely well drained like high ground observed on the east corridor north of Carpenter Lake.

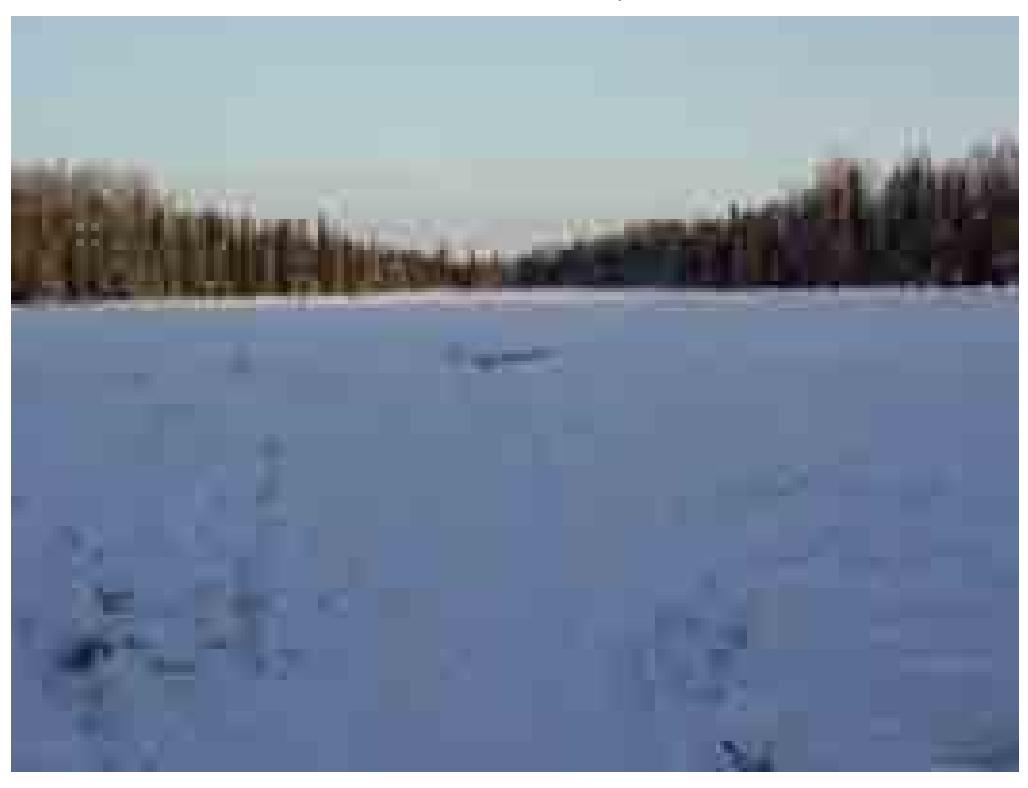
Photo 32: Station West 16, small boggy area surrounded by tall spruce and birch trees. Likely an overgrown pond.

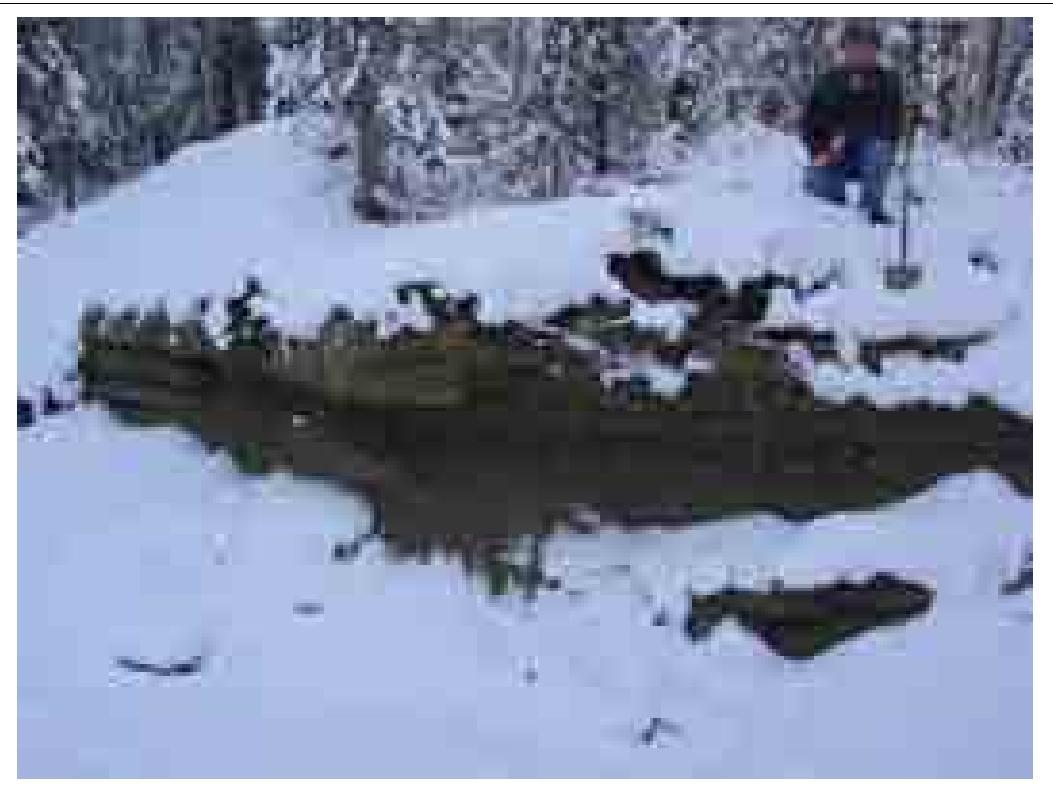
Photo 33: Station West 18, a fresh excavation about 10 to 15 feet deep exposing relatively clean gravelly sand. Soils are crossbedded like an alluvial deposit.

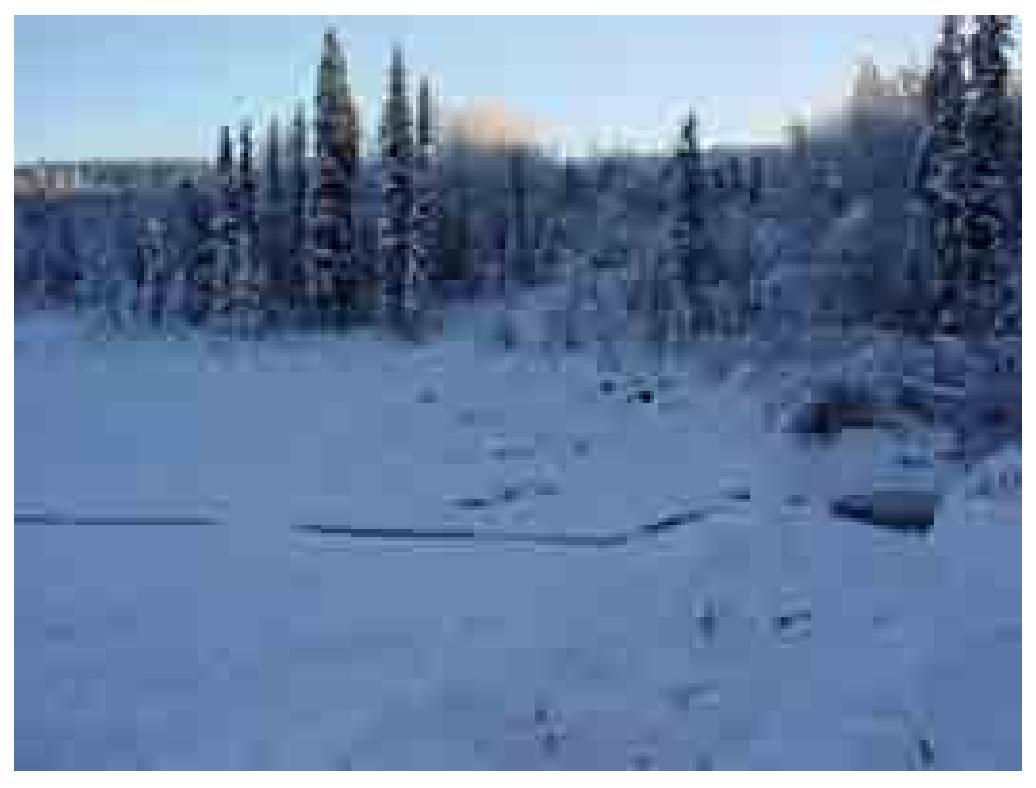
Photo 34: Station West 20, small creek that drains a boggy area into Rainbow Lake. Sand and gravel observed in the creek bed.

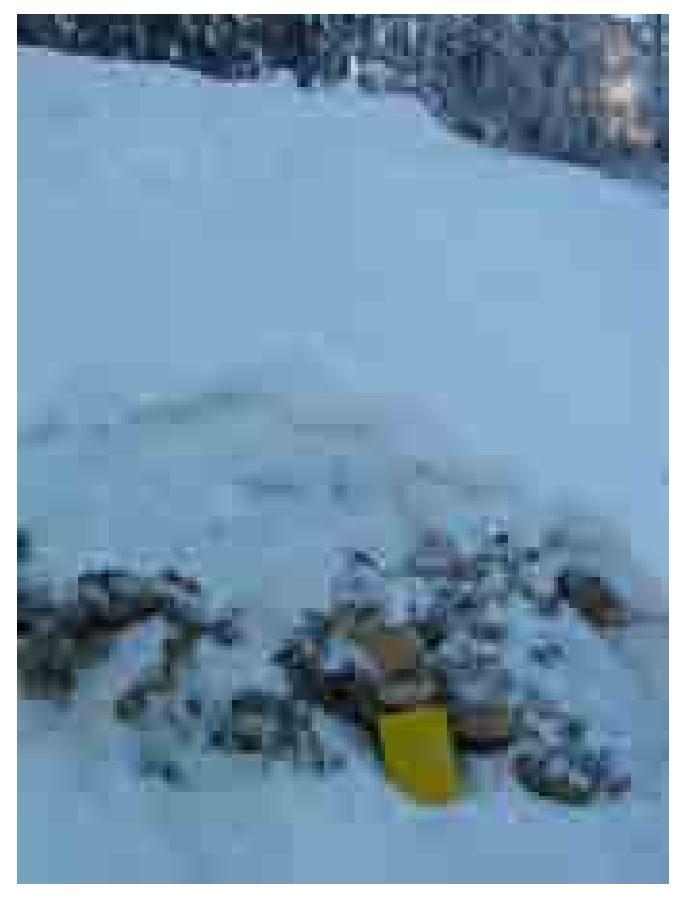
Photo 36: Station West 22, small cut on the east hillside above Jean Lake. Areas with no ice or snow cover reveal relatively gravelly soils.

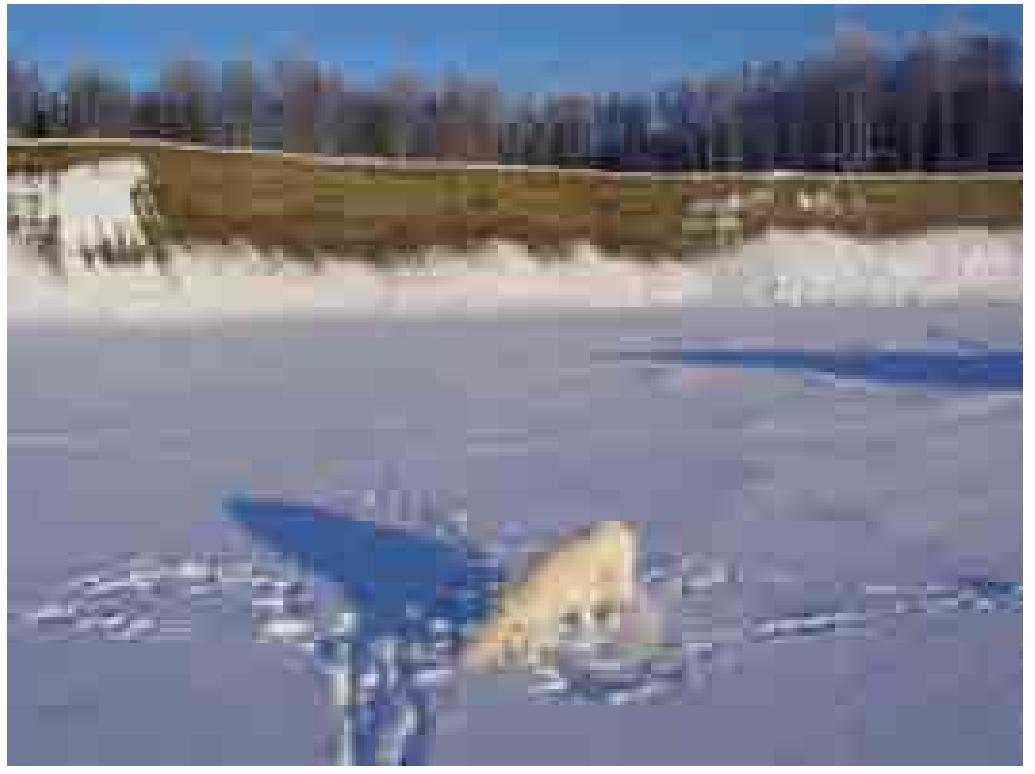
Photo 37: Station West 23, a very large borrow pit east of Long Lake. Soils in cut are clean, interbedded sands and gravels, likely alluvial. The cut face is approximately 30 feet high.
